**HAZARDOUS MATERIALS SURVEY  
FINAL REPORT**

**UC Davis Health Education Building  
4610 X Street  
Sacramento, CA 95817**

**UC Davis Health Education Building  
NET V2 Project**

**May 10, 2024**

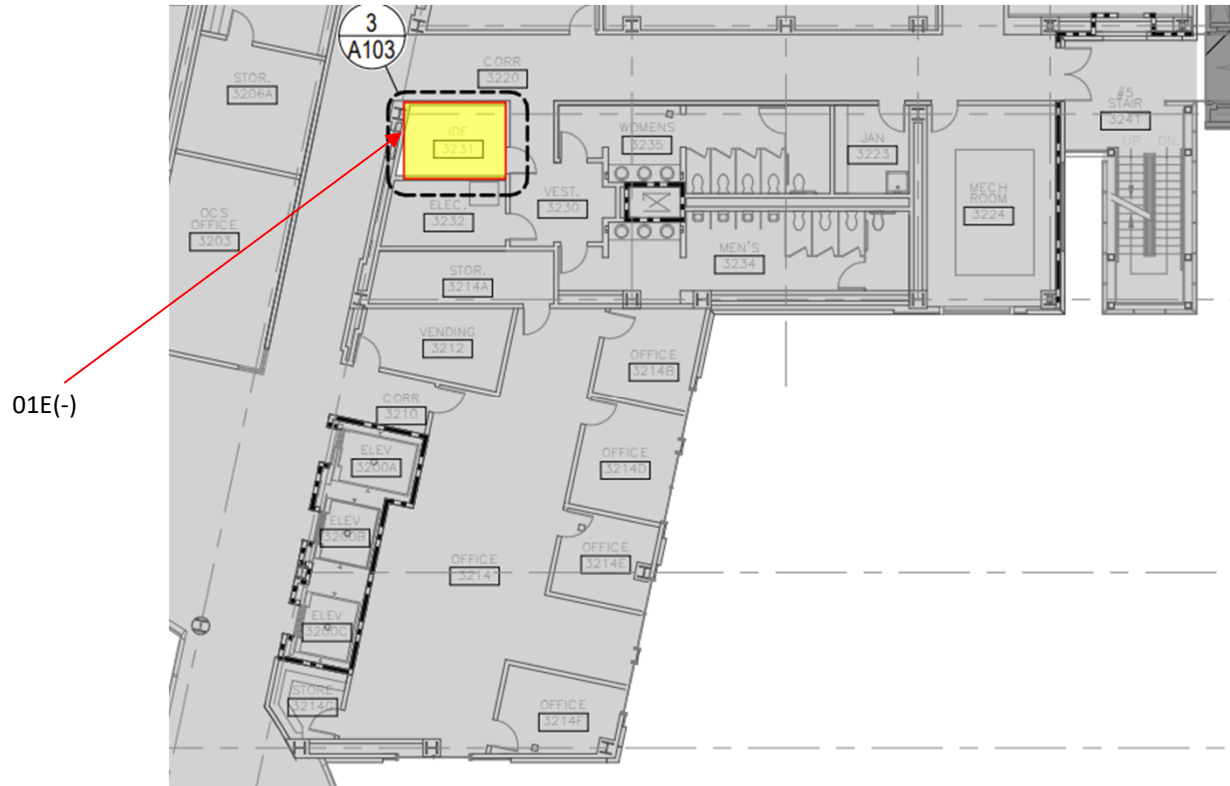
# UCDH Education Building Third Floor

01E(-)

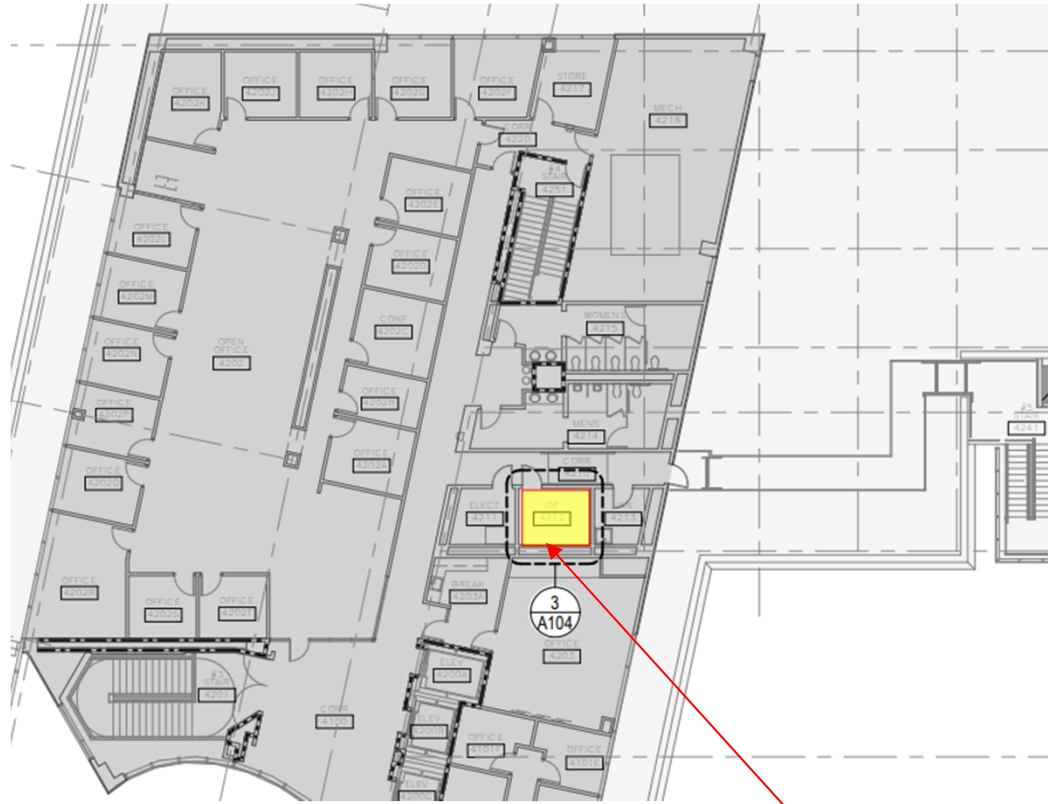
# UCDH Education Building Fourth Floor

01F(-)

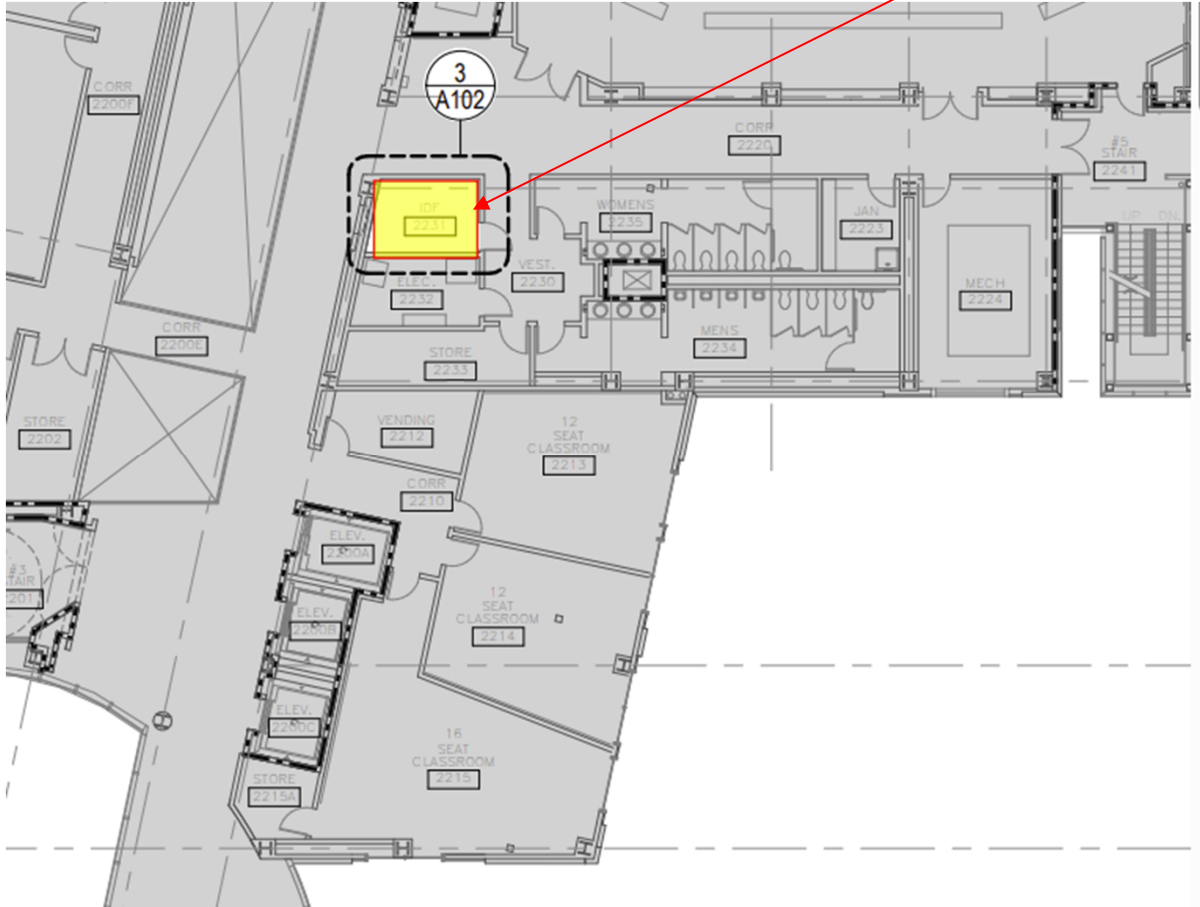
# UCDH Education Building Second Floor

03Pb(-)
